2023/01/07 - Colorado - Pumphouse Lake, southwest of Rollins Pass

Published 2023/01/14 by Jason Konigsberg, Ethan Greene - Colorado Avalanche Information Center

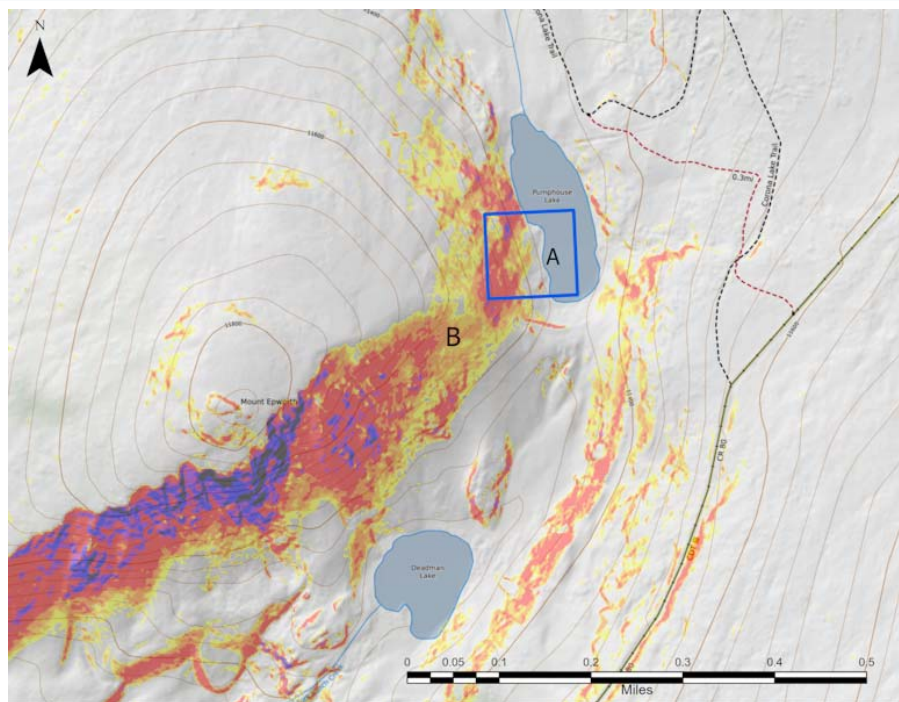
Figure 2: A topographic map of Mount Epworth with slope angle shading. The avalanche occurred within the blue box. "A" indicates the approximate burial locations of Riders 1 and 2. "B" indicates the sympathetically triggered avalanche on the southeast-facing slope. Slope angle is shaded with Caltop fixed bins: 27 to 29 degrees in yellow, 30 to 32 degrees in orange, 32 to 34 degrees in light red, 35 to 45 degrees in dark red, 46 to 50 degrees in purple (Data from ESRI, Caltop, Garmin, and USGS).

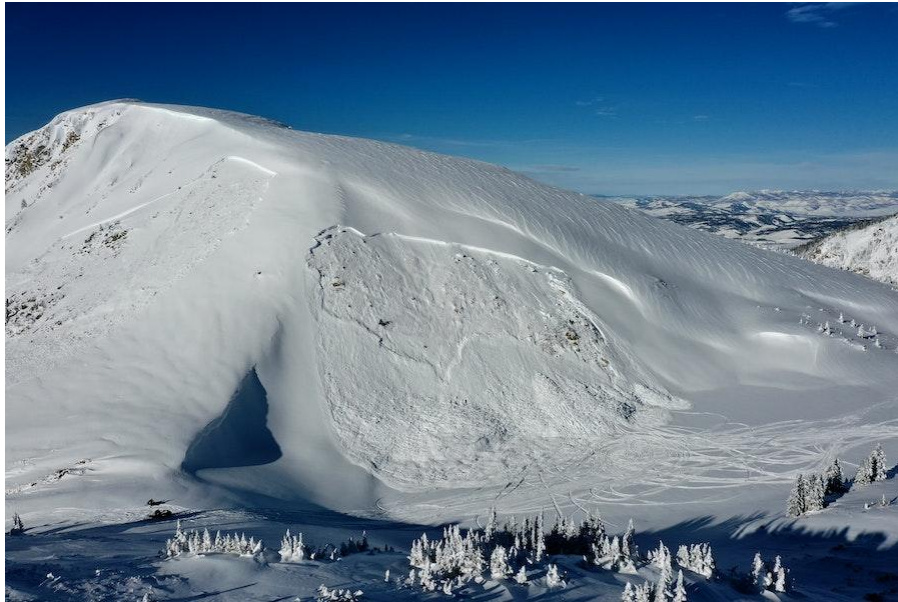
The avalanche occurred on an above-treeline, east-facing slope on Mount Epworth above Pumphouse Lake, three-quarters of a mile southwest of Rollins Pass. It was a large avalanche unintentionally triggered by a snowmobiler. It was medium-sized relative to the path and produced enough destructive force to bury, injure, or kill a person. The avalanche broke on a layer of faceted crystals near the ground (HS-AMu-R3-D2-O). Westerly winds drifted large amounts of snow onto the slope where the avalanche started. The avalanche ran into Pumphouse Lake, breaking the lake ice and exposing water in places. The avalanche broke approximately 5 feet deep and about 400 feet wide. It ran 175 vertical feet. Another large avalanche released sympathetically on the southeast face of Mount Epworth above Deadman Lake (HS-AMy-R2-D2).

Figure 3: The fatal avalanche is in the center of the image, above Pumphouse Lake. The avalanche in the left of the image ran simultaneously. Image taken January 8, 2023.

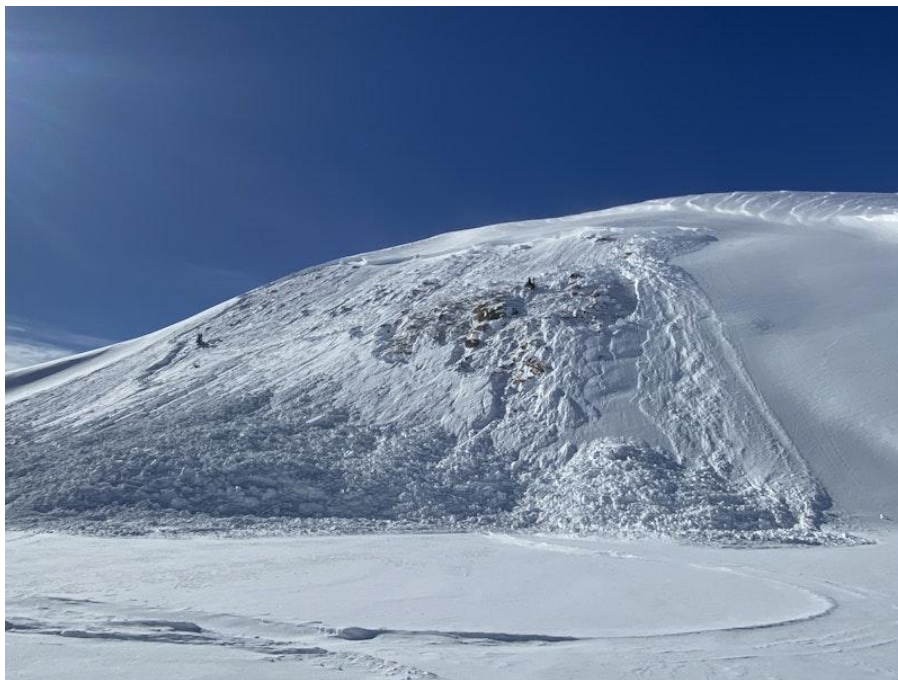
Figure 4: Looking across at the east face of Mount Epworth. Pumphouse lake is the flat area at the bottom of the image. Rescuers estimated that the avalanche debris was up to 15 feet deep where the slope flattens onto the lake ice.

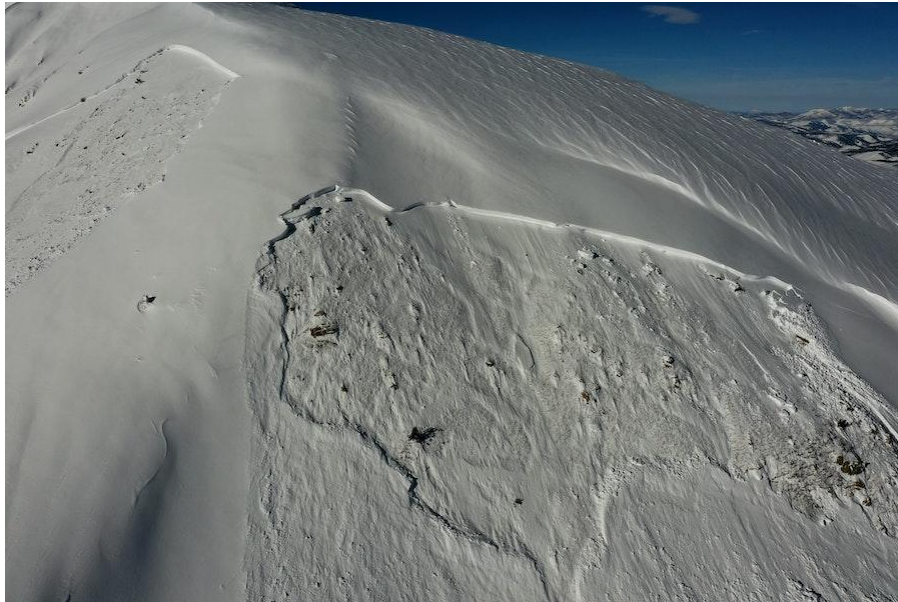
Consistent snowfall in December, with several wind events and periods of warm temperatures, formed a cohesive slab of snow above the faceted basal layers. Wind drifting added additional snow resulting in a slab over 5 feet thick on the slope that avalanched.

Figure 5: A drone image of the starting zone. The textured snow below the ridge line is indicative of wind loading.

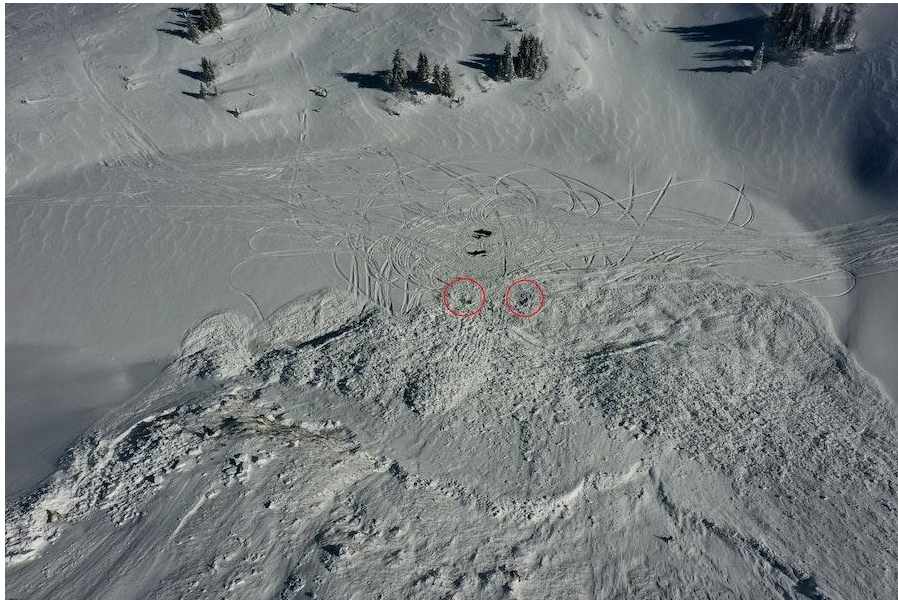
About half of the avalanche class searched with their transceivers for Rider 1. Within a few minutes, they pinpointed a signal with a very low distance reading and began digging. They found Rider 1 under two to three feet of debris. He was face down in the lake, and was unresponsive.

team probed the area and located Rider 2. They excavated Rider 2, who was fully submerged in the lake water beneath about 2 feet of avalanche debris. The team transported his body out of the field.

Figure 6: An image taken from a drone of the avalanche runout and Pumphouse Lake. The red circles indicate where Rider 1 and 2 were buried on the lake in a mix of slushy avalanche debris and water.

Lakes are dangerous terrain traps that can make rescue more complicated. Riders 1 and 2 were the fourth and fifth fatalities in the Front Range involving lakes. There was a fatal avalanche accident on this slope on [February 14, 2021](#). Lake water also complicated the 2021 accident. In [January 2016](#), an avalanche on St Marys Lake, about 6.5 miles south of Pumphouse Lake, caught and killed a climber. The avalanche broke the lake ice, and the climber's legs were partially submerged. In [November 2001](#), an avalanche caught two backcountry skiers and shattered the ice on Yankee Doodle Lake, about 1.5 miles east of Pumphouse Lake. The slide swept one skier into the middle of the lake, and he swam through about 200 feet of broken ice to reach the shore.

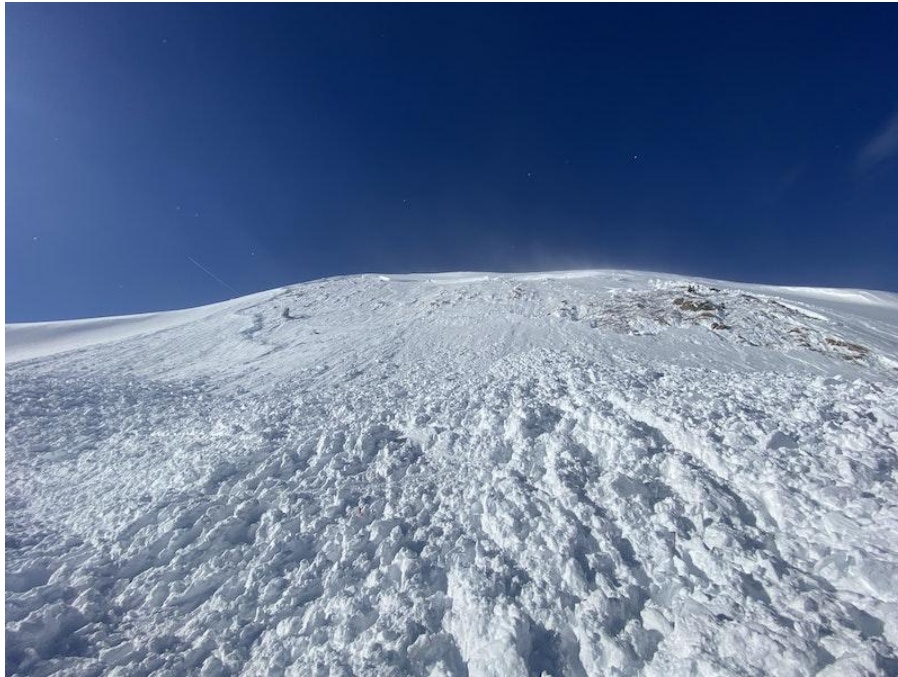
Figure 7: Looking up at the crown face of the avalanche from near the burial location of Rider 1 and Rider 2.

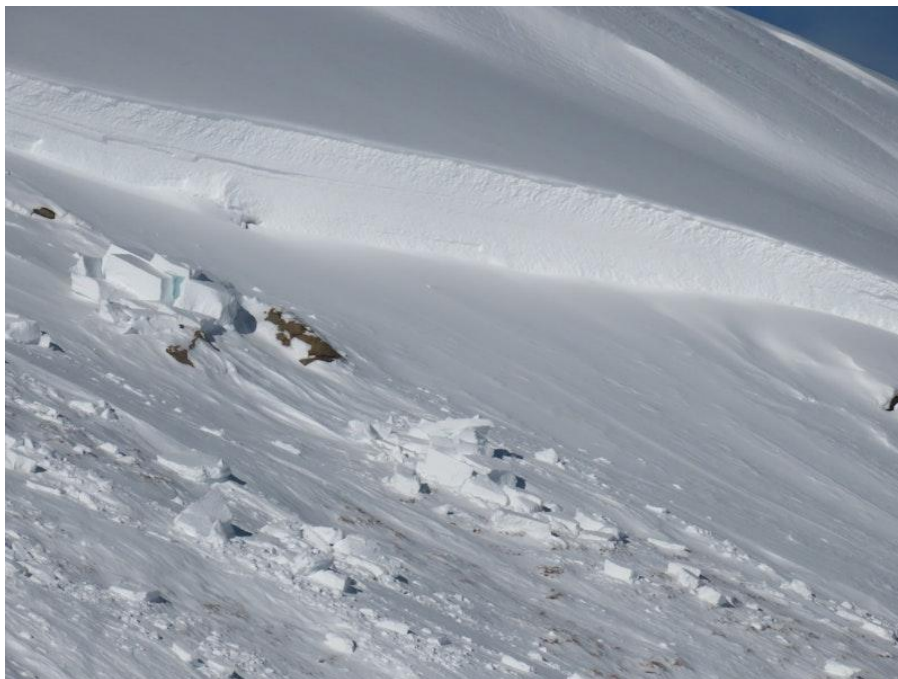
Figure 8: This is the deepest portion of the crown face of the avalanche. It was about 6 feet deep at its deepest point.
